TECHNICAL REPORT REMR-CO-3

**CASE HISTORIES OF CORPS BREAKWATER
AND JETTY STRUCTURES**

Report 3

NORTH CENTRAL DIVISION

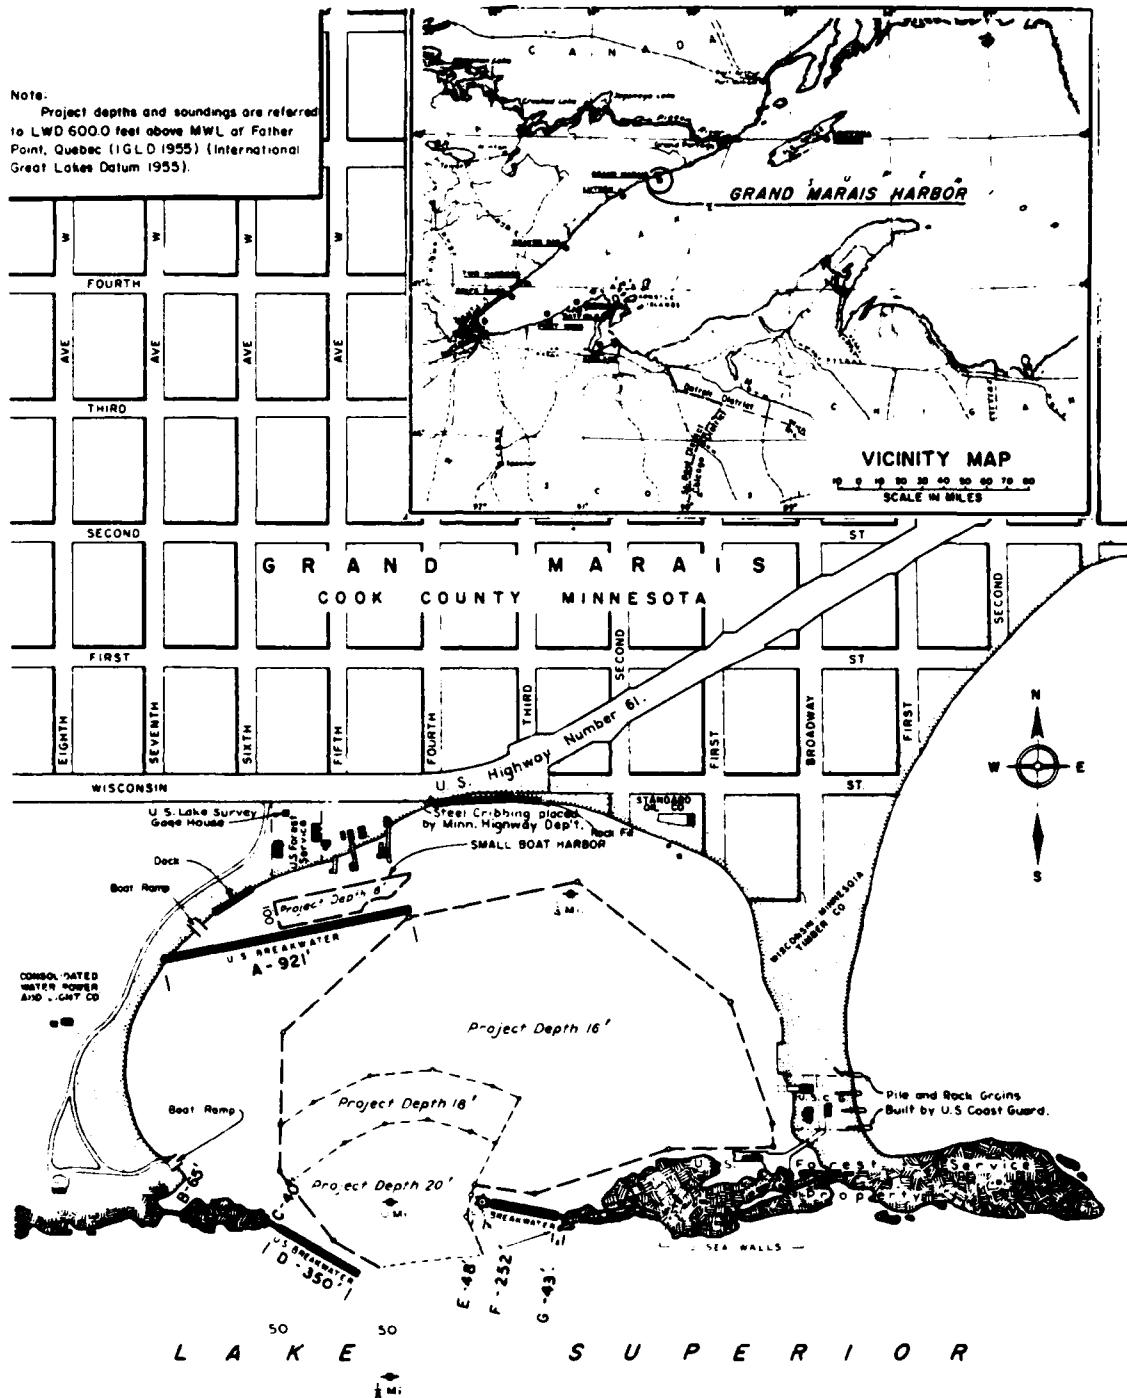
Figure 5. Grand Marais Harbor, Minnesota

Date(s)	Construction and Rehabilitation History
1883- 1884	A 300-ft-long rock-filled timber-crib breakwater was constructed at the site (Figure 5, Sections E and F) during this period. The outer 48 ft of the structure (Figures 5 and 6, Section E) was built 40 ft in width, and the remaining 252 ft (Figures 5 and 6, Section F) was constructed 30 ft in width.
1901- 1902	A 350-ft-long rock-filled timber crib breakwater was constructed west of the first structure during this period (Figures 5 and 6, Section D). The structure was built 24 ft wide.
1925	A concrete cap (superstructure) was constructed on the outer 48 ft of the structure built during 1883-84. The crest el was +7 ft lwd (Figure 6, Section E).
1926	A concrete cap (superstructure) was completed on the 30-ft-wide, 252-ft-long structure built during 1883-84. The crest was constructed at an el of +7 ft lwd (Figure 6, Section F).
1933	A concrete cap (superstructure) was installed on the breakwater built during 1901-02. The crest el was +7 ft lwd. Heavy riprap was placed on both sides of the structure (Figure 6, Section D). Also in 1933 a 43-ft-long concrete breakwater connecting the east breakwater to shore was constructed (Figure 5, Section G). The structure was 12 ft wide and had a crest el of +7 ft lwd (Figure 6, Section G).

Date(s)	Construction and Rehabilitation History
	additional stone to raise the el in some locations above the water level. The concrete cap of the west breakwater was noted shifting, cracking, separating, and/or tilting in some locations. Concrete spalling also was noted.
1986	The general condition of the east and west breakwaters is considered fair. The rubble-mound inner breakwater is in good condition.

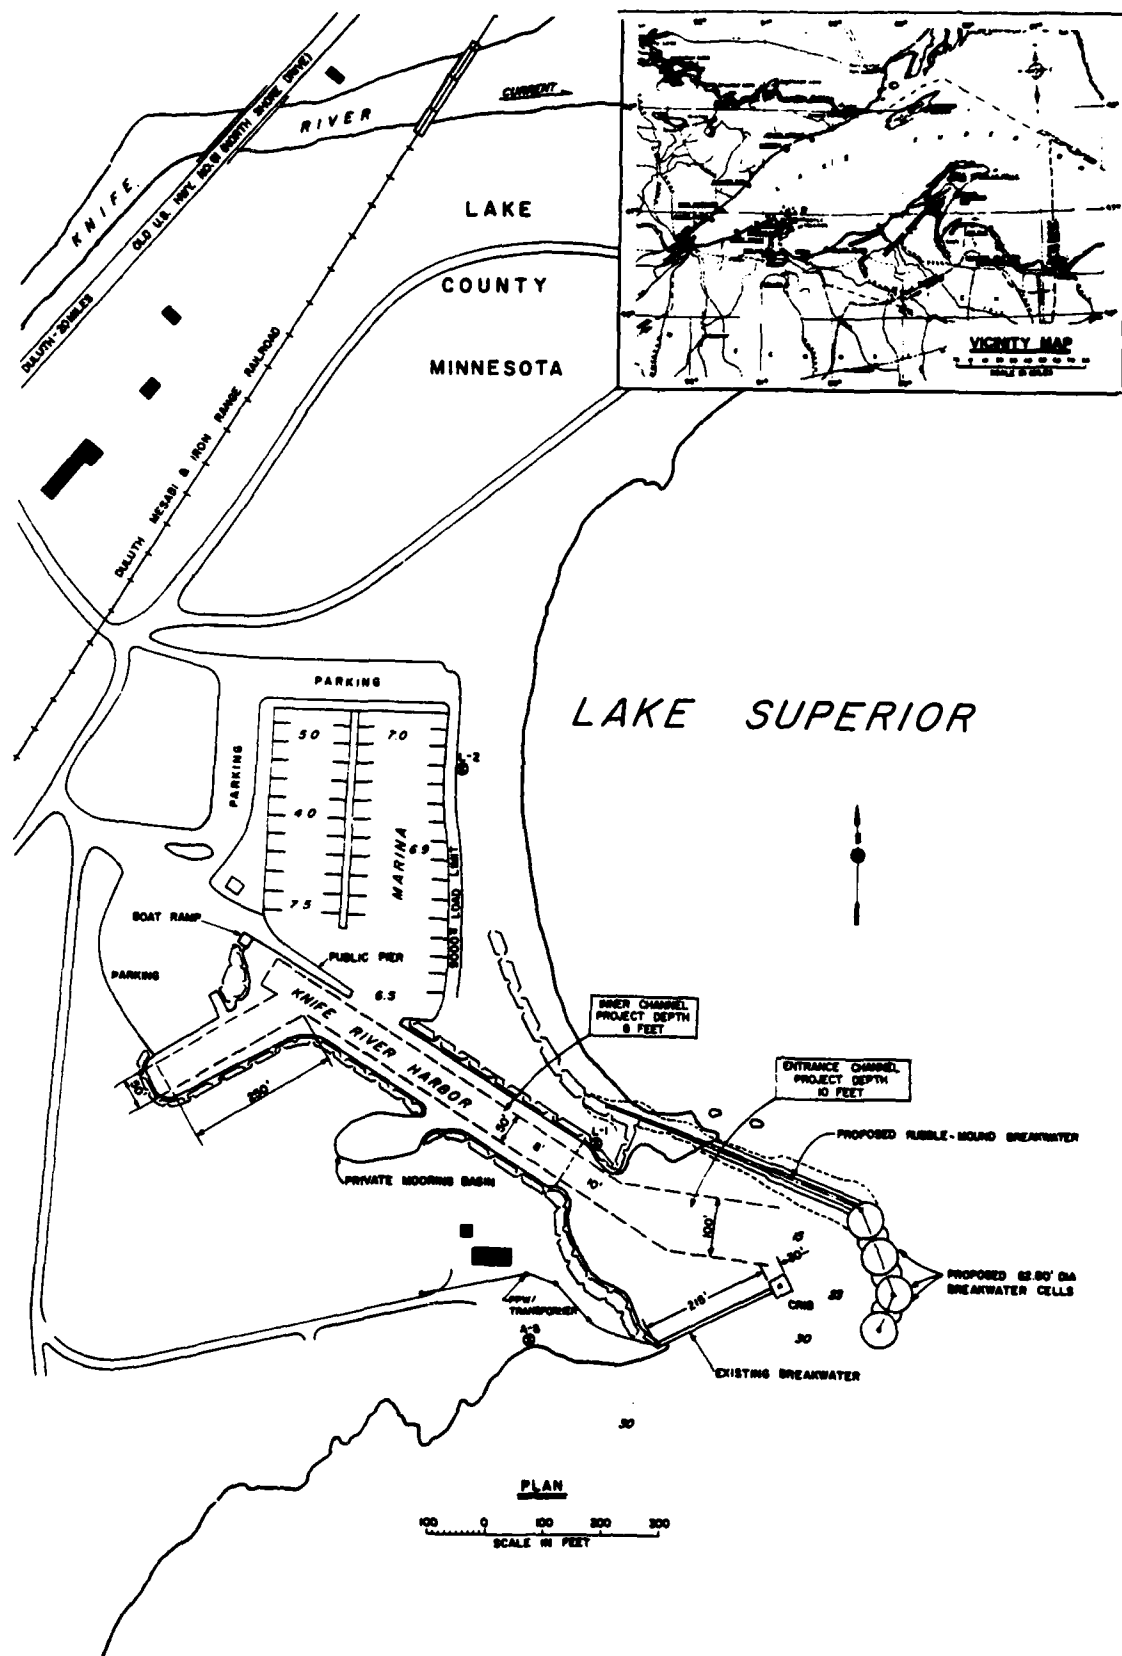
Figure 9. Knife River Harbor, Minnesota

Date(s)	Construction and Rehabilitation History
1957- 1958	Construction of a 245-ft-long breakwater occurred at the site (Figure 9) during this time frame. The shoreward 215 ft of the structure was of rubble-mound construction, and the lakeward 30 ft was a stone-filled timber crib breakwater (Figure 10). The rubble-mound portion of the breakwater had a crest width of 8 ft and an el of +8 ft lwd. Side slopes of 1V:1.5H were constructed, and armor stone ranging from 3 to 5 tons was used. The timber crib structure was 30 ft wide with a crest el of +9 ft lwd. It was constructed on a stone mattress and had a timber deck. Rock was placed around the toe of the structure comprised of cover stone ranging from 1 to 5 tons. After construction it was noted that a design deficiency existed in that the breakwater did not effectively protect the harbor entrance from adverse wave conditions from northeasterly storms.

1974	A modification to the project authorized the construction of a 451-ft-long rubble-mound breakwater with four 62.8-ft diam steel sheet-pile cells (250 ft) at its head (Figure 9). Construction of the breakwater has not been initiated.
1986	Since the original breakwater was completed, it has sustained some localized damage which was repaired during routine maintenance. The structure is presently in good condition.

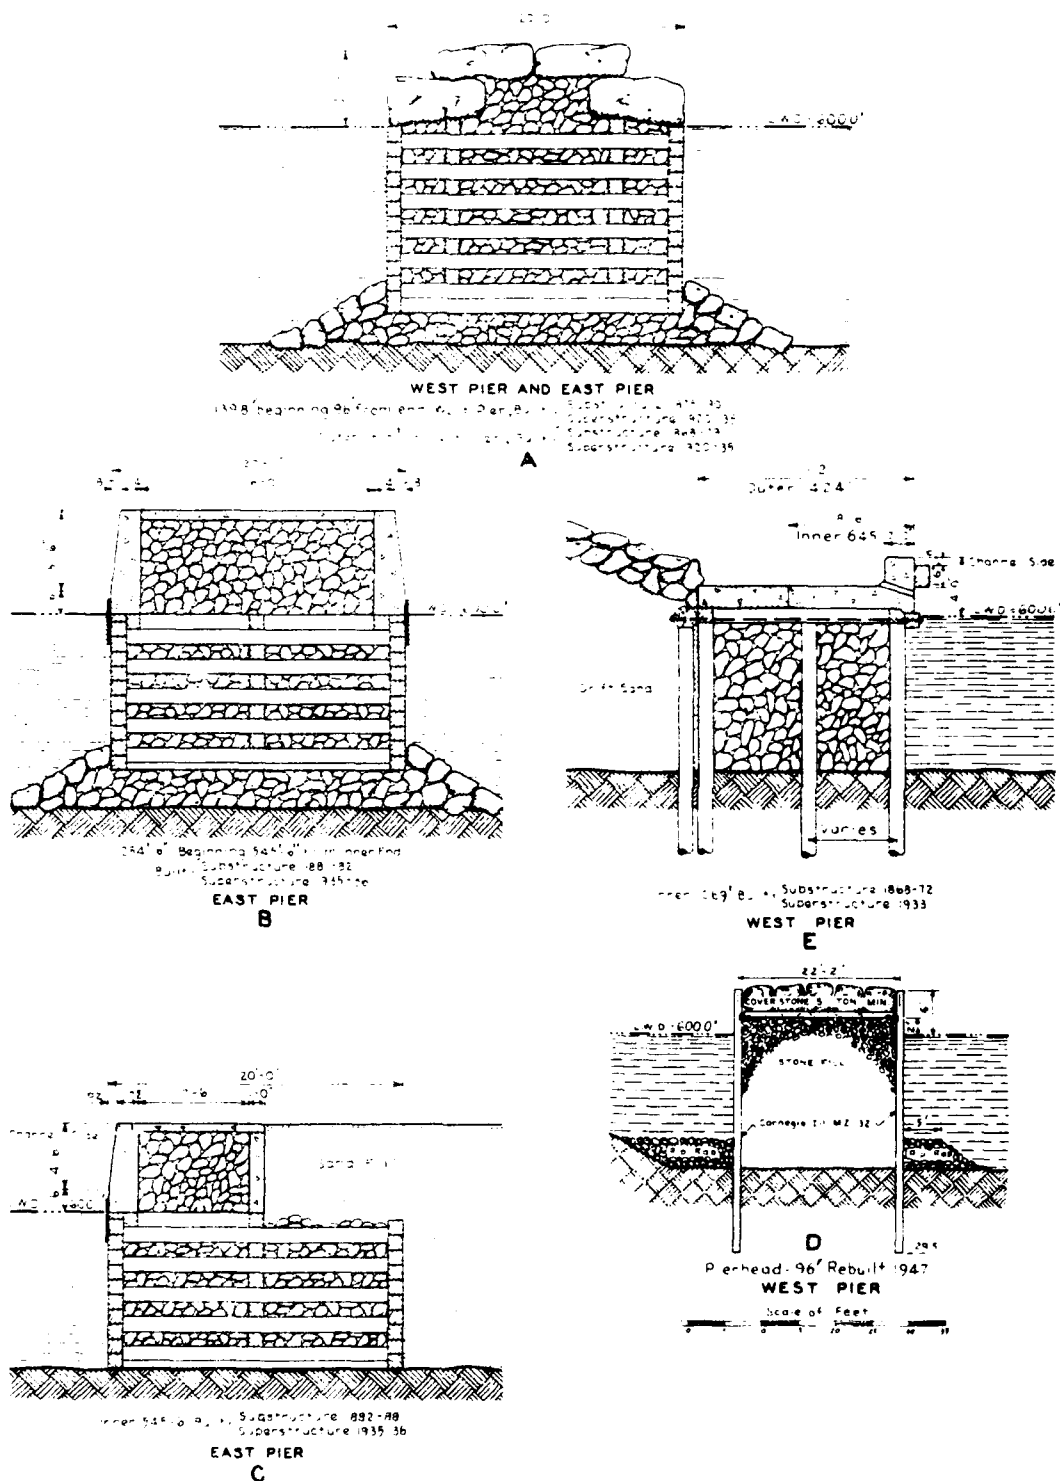
Figure 29. Typical pier cross sections, Ontonagon Harbor, Michigan

1920- 1935	A stone superstructure was built on 1,515 and 1,398 ft of the east and west piers, respectively (Figure 29, Section A). The el of these piers was +5 ft lwd.
1933	A concrete cap (superstructure) was constructed on the inner 1,069 ft of the west pier (Figure 29, Section E). The el of the channel side of the pier was +4 ft lwd.
1935- 1936	A stone and concrete cap (superstructure) was installed on 800 ft of the east pier (Figure 29, Sections B and C). The shoreward 545 ft of structure had a crest el of +5 ft lwd (Section C), while the remaining pier had an el of +6 ft lwd (Section B).
1947	The 96-ft-long west pierhead was rebuilt with steel sheetpiling that was stone filled. It was capped with 5-ton minimum cover stone. The pierhead was 22 ft wide with a crest el of +6 ft lwd. Riprap was installed to provide toe protection. It is not clear when the pierhead was originally constructed.

1983	A structural inspection of the piers was made. A void up to 20 ft wide was observed on the west pier, and sand was being lost through the cribbing under the superstructure. Additional stone was required

Date(s)	Construction and Rehabilitation History
	at various locations on both piers, and it was noted that the concrete superstructure had spalled in areas. In the summer of this year, core and cover stone were placed where necessary to repair the structures.
1986	The piers presently are in fair condition. An aerial view of Ontonagon Harbor piers is shown in Figure 30.

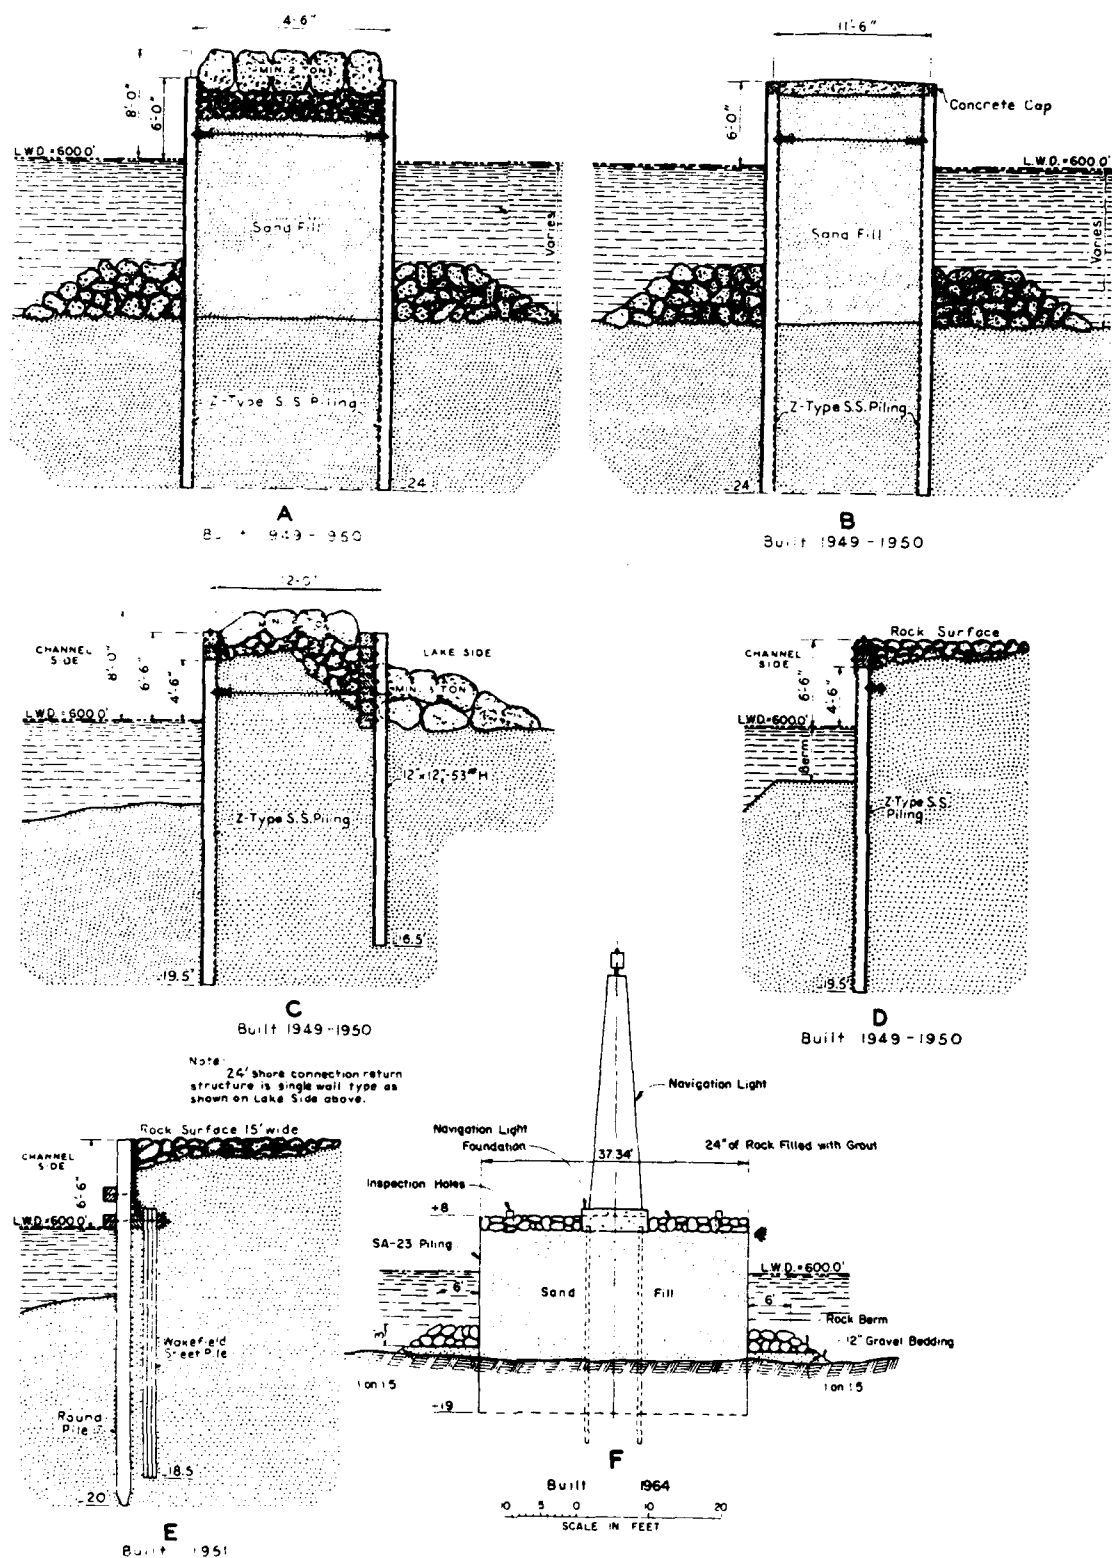
Figure 40. Typical structure cross section,
Grand Traverse Bay Harbor, Michigan

1964	Construction of a 164-ft-long north pier extension was completed (Figures 39 and 40, Section F). Cellular steel sheet piles with diameters of 37.3 ft were used. These cells were sand filled with 2-ft-thick rock (filled with grout) caps. The el of the cellular structures was +8 ft lwd, and stone toe protection was installed on the lakeward side.
1975	A 180-ft-long cellular sheet-pile north breakwater extension was completed (Figure 39).
1979	An inspection of the piers indicated that repairs were needed on the cap of the north pier at the intersection of the cell and Section A. Additional repairs were needed on the outer three cell caps.
1981	The north pier caps, identified in need of repair in 1979, were repaired.
1983	An inspection of the structures revealed that the cap on the south pier had settled as much as 6 in. in some areas. The outer cell of the north pier also had settled (up to 14 in.) and had several large cracks. Additional riprap stone also was required at Section C. Repairs to the structures were subsequently made.

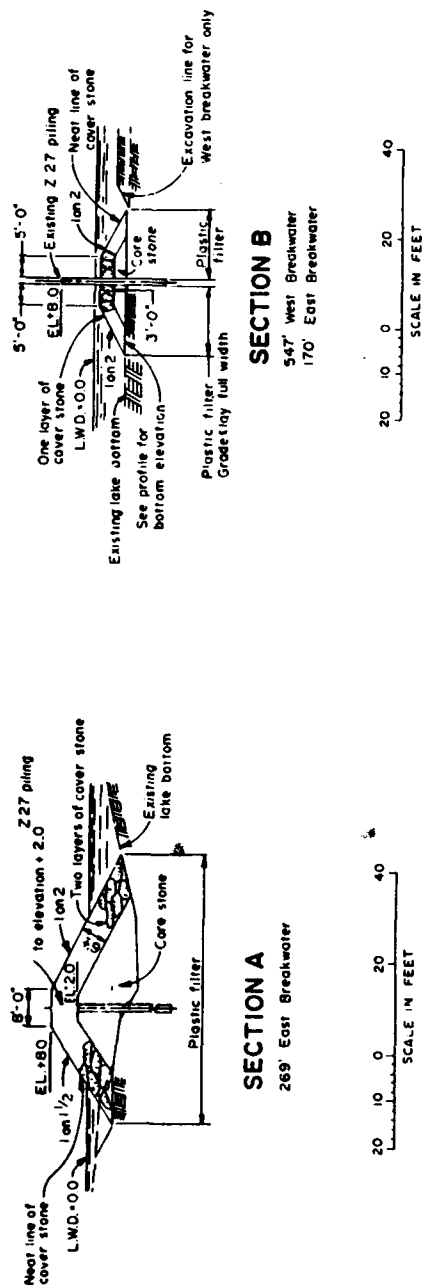
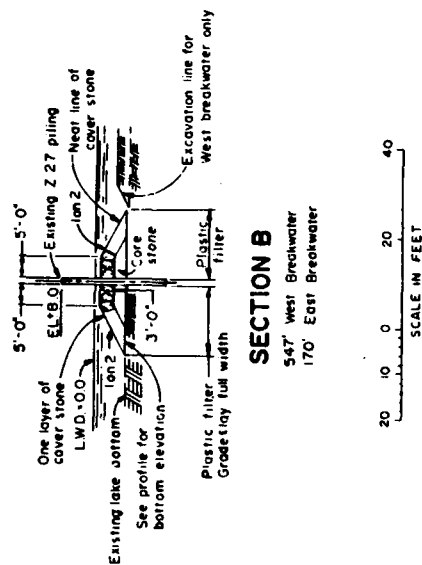
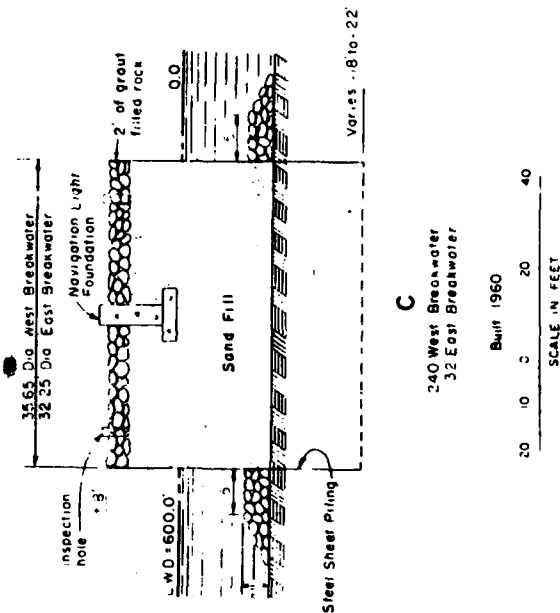
Figure 43. Typical breakwater cross sections, Big Bay Harbor, Michigan

1969	The east breakwater was rehabilitated.
1979	An inspection of the harbor structures indicated that additional riprap was needed on both sides of the west breakwater (Figure 43, Section B). The stone was eventually placed.
1986	The breakwaters presently are in good condition. An aerial view of Big Bay Harbor breakwaters is shown in Figure 44.

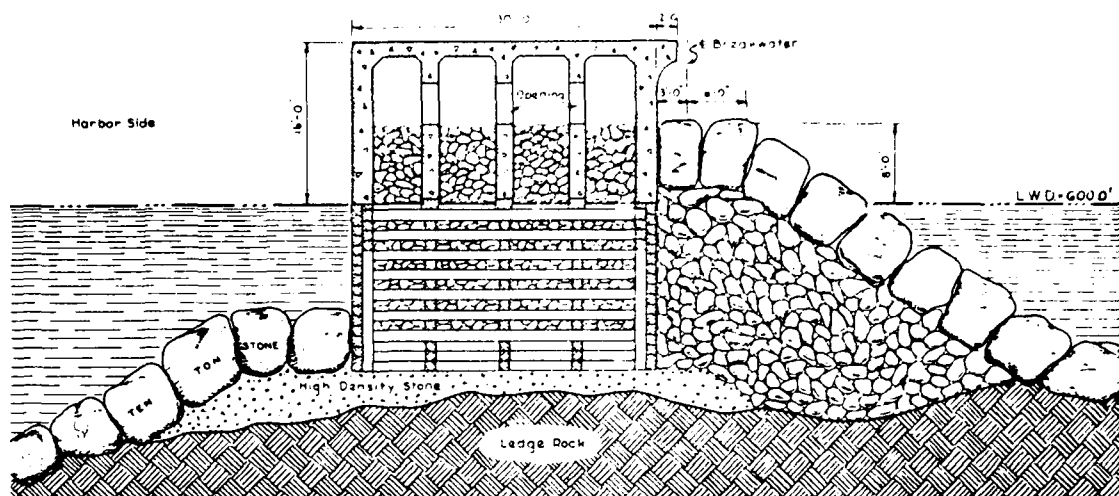
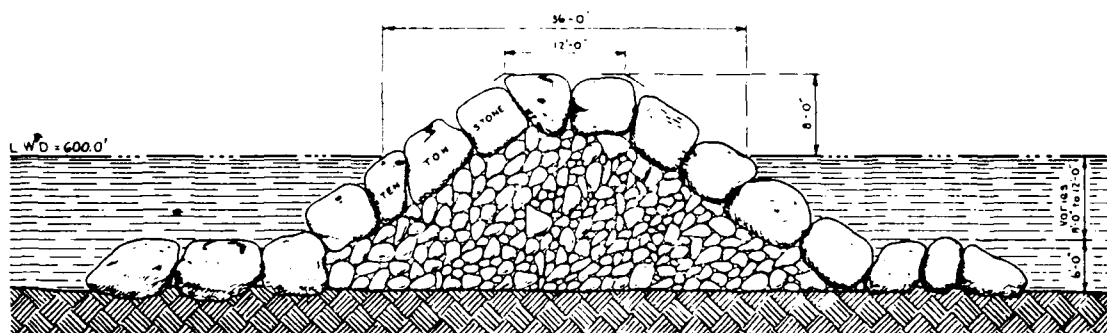
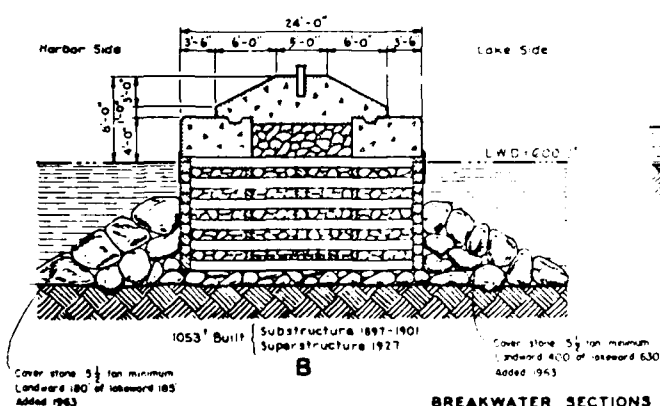
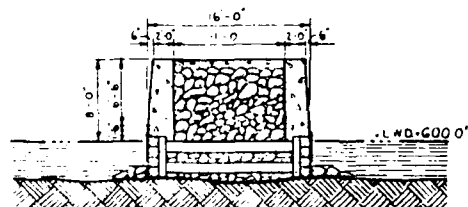
Figure 46. Typical breakwater cross sections,
Presque Isle Harbor, Michigan

Date(s)	Construction and Rehabilitation History
1897- 1901	Construction of a 1,053-ft-long breakwater was performed during this period (Figures 45 and 46, Section B). The structure was a 24-ft-wide stone-filled timber crib breakwater with riprap toe protection.
1903	A 163-ft-long stone-filled timber crib breakwater (16 ft wide) was completed connecting the original structure to shore (Figures 45 and 46, Section A).
1927	A stone and concrete capped superstructure was built on the existing structures (Figures 45 and 46, Sections A and B). The crest el of the structure was +8 ft lwd.
1938	Construction of the breakwater head was completed. The structure was a stone-filled timber crib breakwater that was 30 ft in width (Figures 45 and 46, Section D). The stone portion of the substructure and stone placed on the lakeward side of the breakwater were installed at an el of +8 ft lwd. Armor stone on the lakeside and toe protection on the harbor side of the structure were in the 10-ton range. The concrete superstructure was built to an el of +16 ft lwd for a lighthouse.

1938- 1939	A 1,600-ft-long rubble-mound breakwater was constructed connecting the breakwater head to the existing structure (Figures 45 and 46, Section C). The crest was 12 ft wide with an el of +8 ft lwd. Ten-ton armor stone was used.
1963	Riprap cover stone (5.5 ton) was installed for a distance of 180 ft on the harbor side and 400 ft on the lakeward side of the original timber crib structure (Figure 46, Section B). The inner 1,216 ft of breakwater was rehabilitated for a cost of \$76,500.
1975	An inspection of the site indicated that the outermost portion of the rubble-mound breakwater needed some minor stone rearranging. This work was completed later in the year.
1986	The breakwater presently is in good condition. An aerial view of Presque Isle Harbor breakwater is shown in Figure 47.

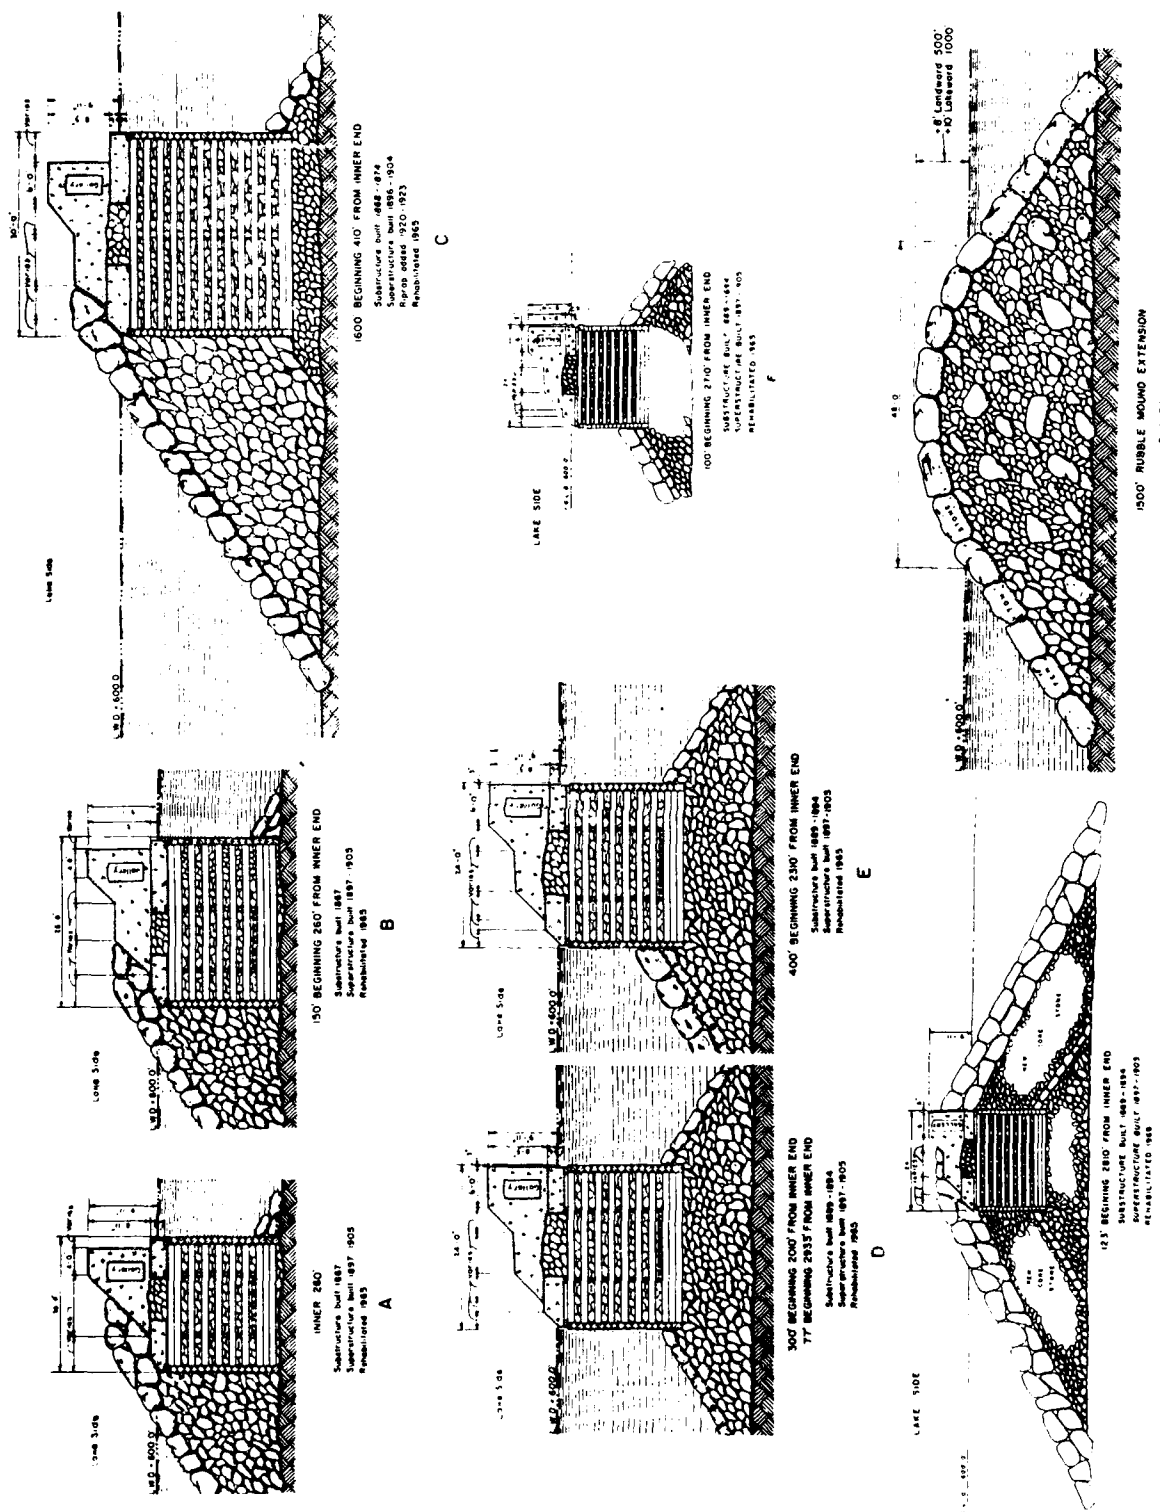
Figure 49. Typical breakwater cross sections, Marquette Harbor, Michigan

1897- 1905	A concrete cap (superstructure) was installed on the remaining portion of the breakwater (Figures 48 and 49, Sections A, B, D, E, F, and G). The superstructure was built to an el of about +10 ft lwd. Stone was added on the lakeside of the inner 410 ft (Sections A and B), and on both sides of the 123-ft-long section designated as G (Figures 48 and 49).
1912- 1918	The breakwater was extended an additional 1,500 ft during this period. The extension consisted of a rubble-mound structure (Figures 48 and 49, Section H). The shoreward 500 ft of structure was installed at an el of +8 ft lwd, and the outer 1,000 ft was constructed to a +10 ft lwd el. The breakwater was constructed of 10-ton armor stone.
1920- 1923	Riprap was placed on the lakeside of the 1,600-ft-long breakwater originally constructed from 1868-74 (Figure 49, Section C).
1965	Rehabilitation of the inner 3,010 ft of the breakwater was completed for a cost of \$465,747.

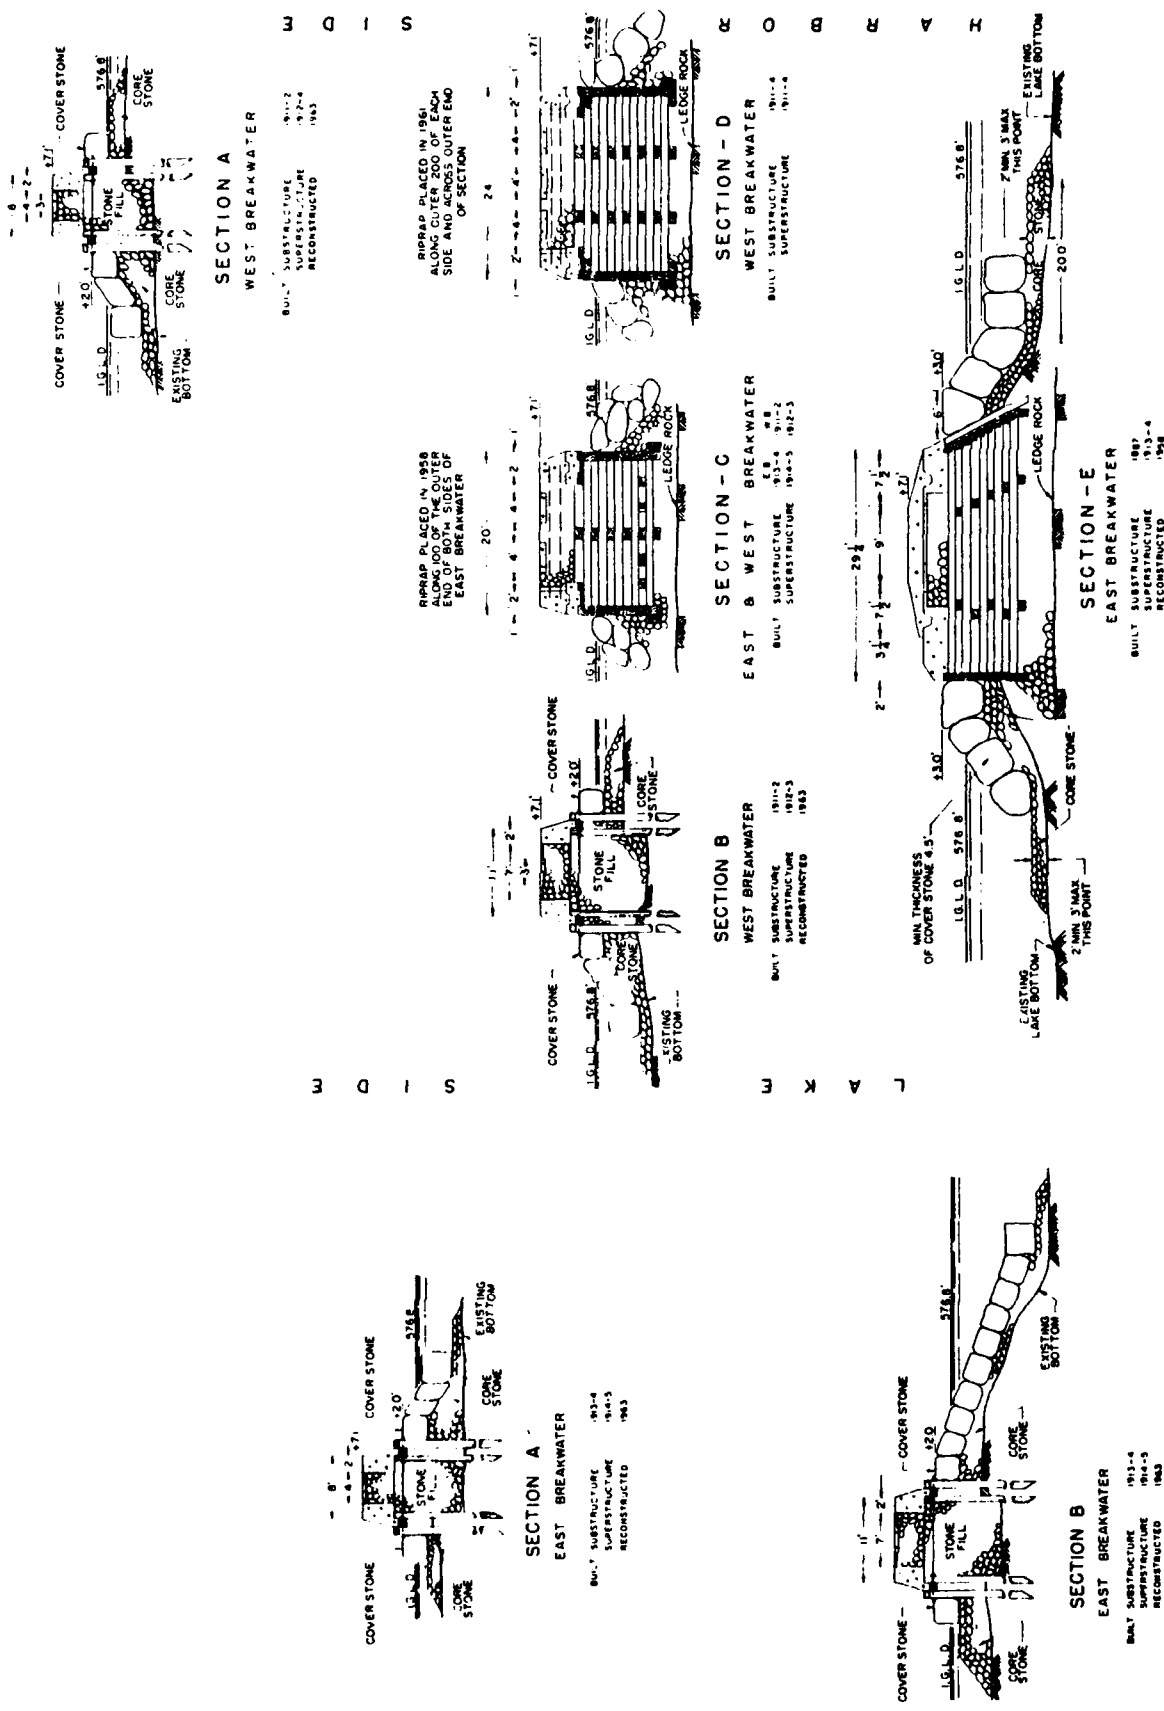
Figure 60. Typical breakwater cross sections, Manistique Harbor, Michigan

Date(s)	Construction and Rehabilitation History
1958	Riprap was placed on both sides of the east breakwater on the outer 100 ft of Section C (Figures 59 and 60). The outer 820 ft of the east breakwater (Figures 59-61, Sections E-G) was reconstructed during this period as rubble-mound breakwaters.
1961	Riprap was placed around the outer end of the west breakwater and for a distance of 200 ft on each side (Figure 59, Section D). Riprap also was placed around the outer end of the east breakwater and 150 ft along each side (Figure 59, Sections F and G).
1963	Rehabilitation of navigation structures included reconstruction of the inner 470 ft and 624 ft of the west and east breakwaters, respectively (Figure 59, Sections A and B). Also included in the rehabilitation was reconstruction of the pier (Figure 59, Section H). The shoreward 88 ft of the pier included a rubble-mound structure (Figure 61, Section H), 8 ft wide, with a crest el of +4 ft lwd and side slopes of 1V:1.5H.

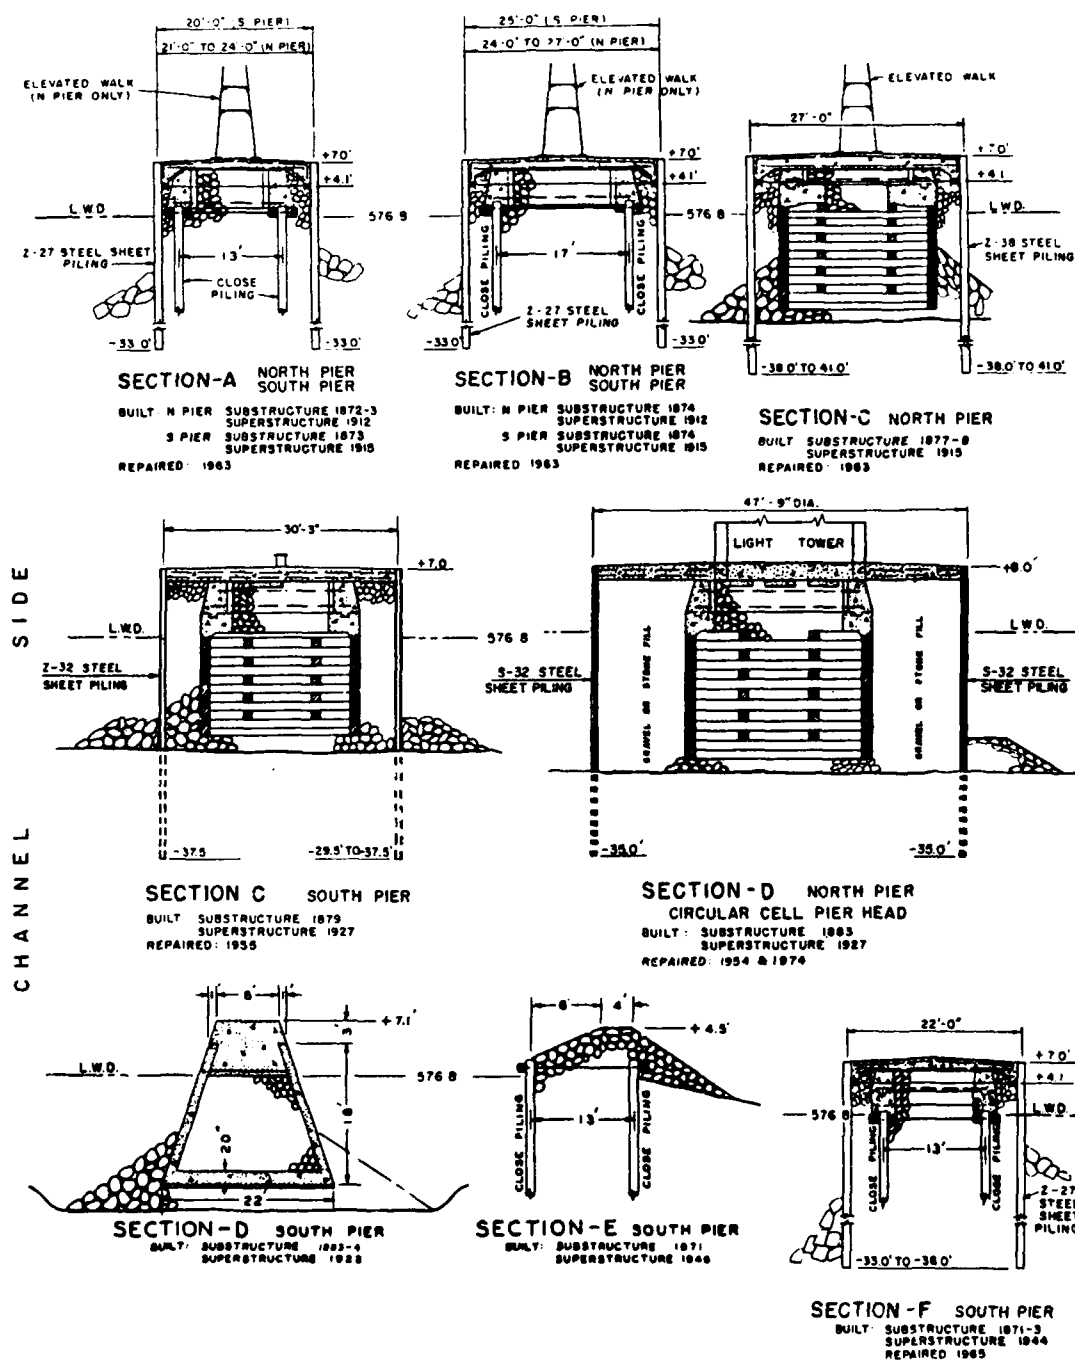
Figure 64. Typical pier cross sections, Menominee Harbor, Michigan

1912	The shoreward 566-ft portion of the north pier was reconstructed, (Figure 63, Sections A and B). Steel sheetpiling was installed that resulted in pier widths ranging from 21 to 27 ft. The structures were stone filled and capped with a concrete superstructure at an el of +7.0 ft lwd (Figure 64, Sections A and B). Riprap toe protection also was installed.
1915	A 508-ft-long portion of the south pier (Figure 63, Sections A and B) and a 596-ft-long portion of the north pier (Figure 63, Section C) was reconstructed in a manner similar to that in 1912. Steel sheetpiling was installed, filled with stone, and capped with a concrete superstructure to an el of +7.0 ft lwd (Figure 64, Sections A, B, and C). A 412-ft portion of the south pier had a 20-ft width (Section A) and the remaining 96-ft portion a width of 25 ft (Section B). the north pier portion (596 ft long) had a width of 27 ft (Section C). Riprap toe protection also was placed on each side of both piers.

1922	The 162-ft-long lakeward end of the south pier was modified (Figure 63, Section D). A rock-filled concrete superstructure was built on the existing rubble-mound pier. The superstructure had a crest el of +7.1 ft lwd with an 8-ft width (Figure 64, Section C).
1927	A 613-ft-long portion of the south pier (Figure 63, Section C) and the 62-ft-long lakeward end of the north pier (Figure 63, Section D) were reconstructed. Steel sheetpiling was placed a width of 30.3 ft apart on the south pier (Figure 64, Section C). The voids were filled with stone, and a concrete superstructure with a crest el of +7.0 ft was installed. Riprap toe protection was also installed. Steel sheetpiling was installed on each side of the north pier which

Date(s)	Construction and Rehabilitation History
	was stone filled and capped. The outer end of the north pier, however, was constructed with a 47.75-ft-diameter cellular sheet-pile structure (Figure 64, Section D). The cell was filled with stone and gravel and capped with a concrete superstructure at an el of +8 ft lwd.
1944	An 880-ft-long portion of the south pier (Figure 63, Section F) was reconstructed similar to other sections of the pier. Steel sheet piles were installed forming a pier width of 22 ft. The voids were stone filled, and the structure was capped with a concrete superstructure installed with a crest el of +7.0 ft lwd (Figure 64, Section F).
1946	The shoreward 525-ft length of the south pier was modified (Figures 63 and 64, Section E). A rubble-mound superstructure was constructed on the existing structure. The crest width of the new superstructure was 4 ft, and it had an el of +4.5 ft lwd.

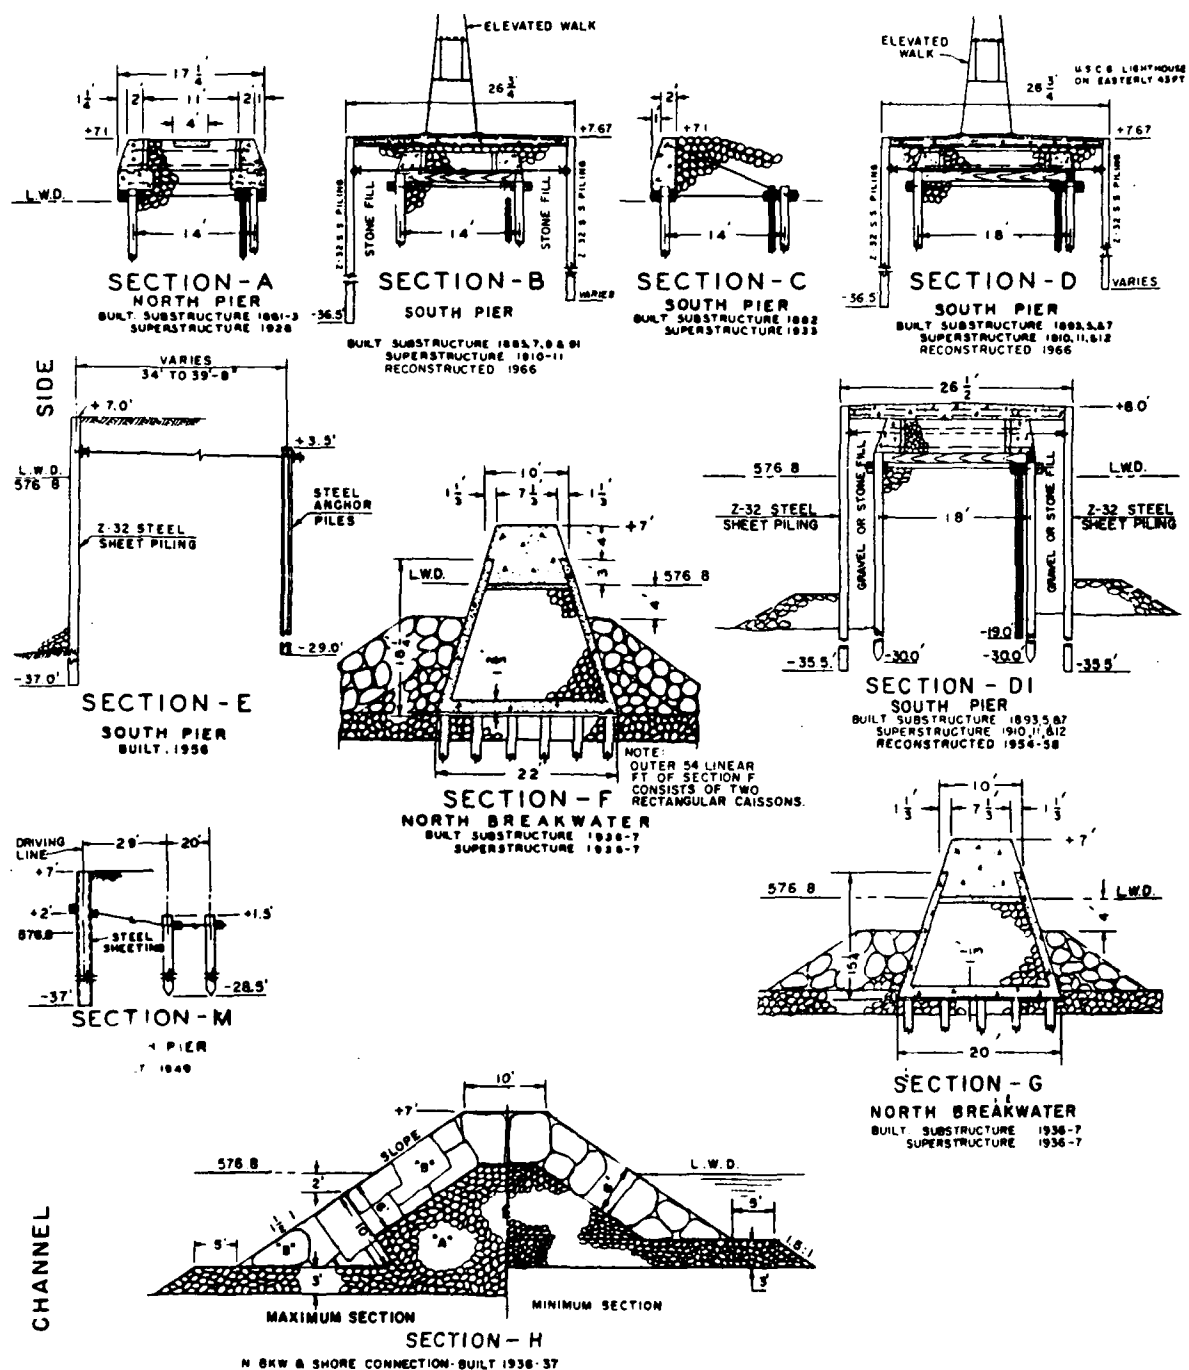
Figure 72. Typical structure cross sections, Kewaunee Harbor, Wisconsin

1983	A site inspection revealed that the structures were generally in good condition. Minor concrete repairs and the placement of additional riprap were recommended for the north breakwater. The work has subsequently been completed. It was noted also that settlement of the north pier on the channel side had occurred.
1986	During their lifetime the structures have undergone reconstruction and normal maintenance repairs. Presently they are considered in good condition.

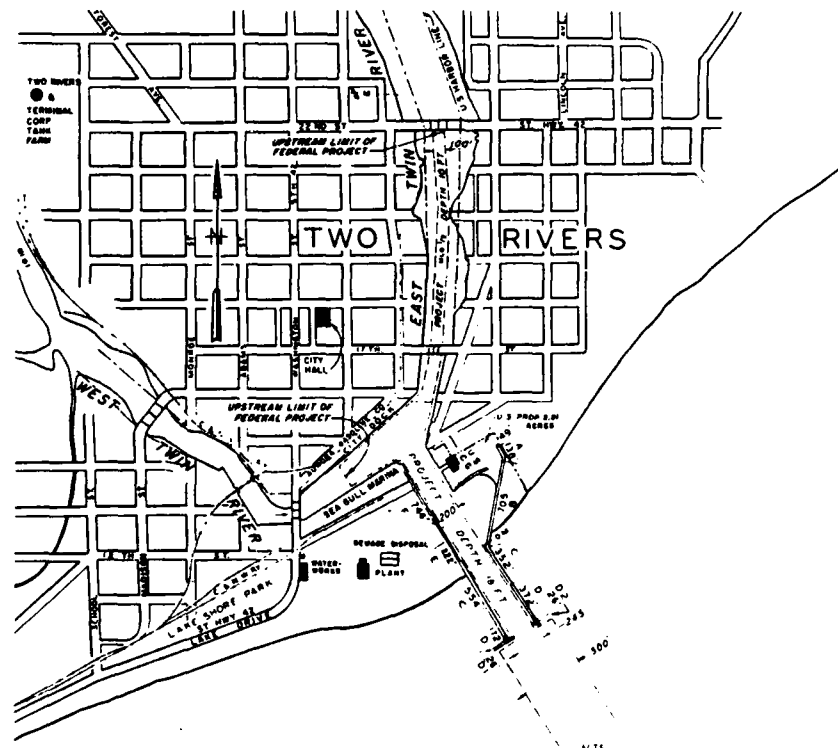
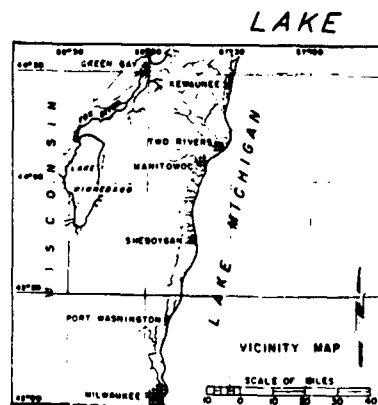
Figure 73. Two Rivers Harbor, Wisconsin

Date(s)	Construction and Rehabilitation History
1984	A site inspection revealed the north pier to be in very good condition and the south pier to be in fair to poor condition. The south pier had sheeting boards that were deteriorated and loose in some areas and not effectively retaining fill material.
1986	The overall condition of the structures is presently considered fair.

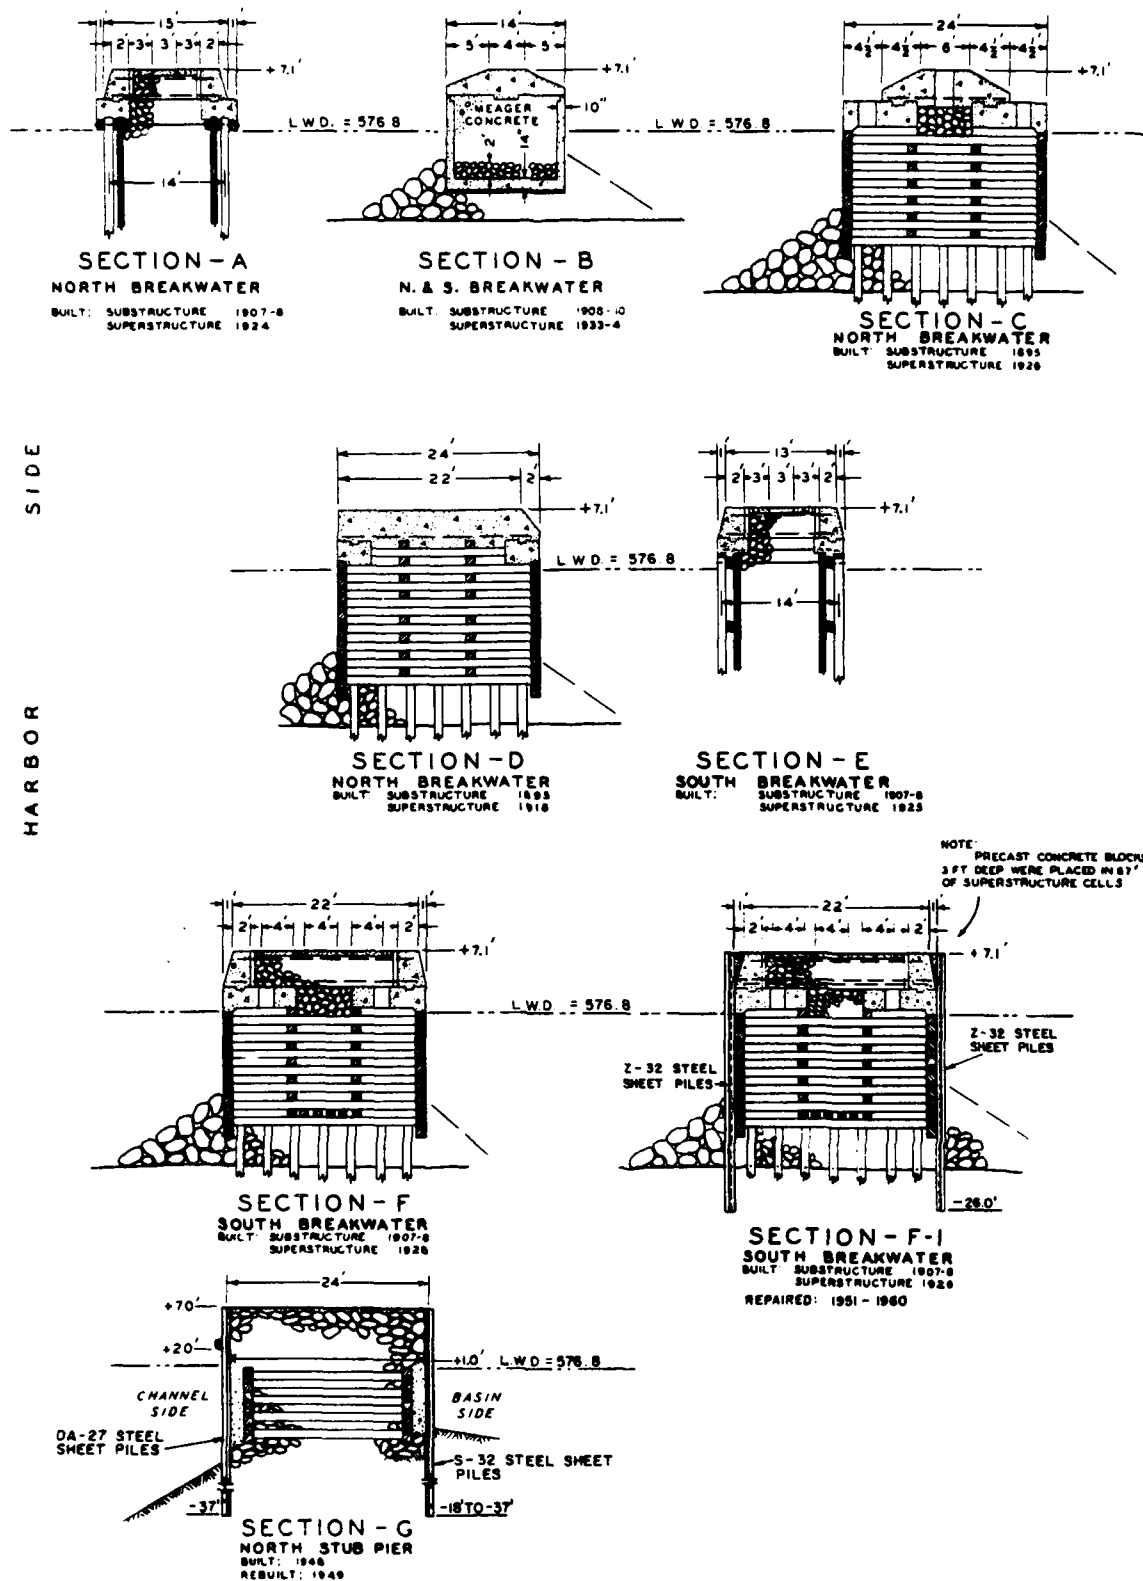
Figure 76. Typical structure cross sections, Manitowoc Harbor, Wisconsin

Date(s)	Construction and Rehabilitation History
1948- 1949	A 74-ft-long stone-filled timber crib north pier was constructed in 1948. (Figure 75, Section G). In 1949 the pier was rebuilt by installing steel sheet piles on each side, filling the voids with gravel, and capping the structure with stone (Figure 76, Section G). The pier was 24 ft in width and had a crest el of +7.0 ft lwd.
1951- 1960	A 148-ft-long portion of the south breakwater (Figures 75 and 76, Section F1) was repaired. Steel sheet piles were installed along each side of the breakwater, and 3-ft-thick precast concrete blocks were placed in the superstructure.
1982	A site inspection made of the structures indicated that the north pier and north breakwater were in good to excellent condition. The shoreward 1,200 ft of the south breakwater was also in good condition; however, the lakeward portions (Sections B, F, and F1) were in need of repair. Settlement of Section B had occurred, and portions of the concrete cap had deteriorated and required patchwork. Sections F and F1 were in fair to poor condition. Stone fill was required under the concrete cap, and in some areas the cap needed replacement.

1983	Repair of the deficiencies noted during the 1982 site inspection was completed.
1986	The structures are presently in good condition.
